EVALUATION OF A FAILED WEBBING PARACHUTE STRAP

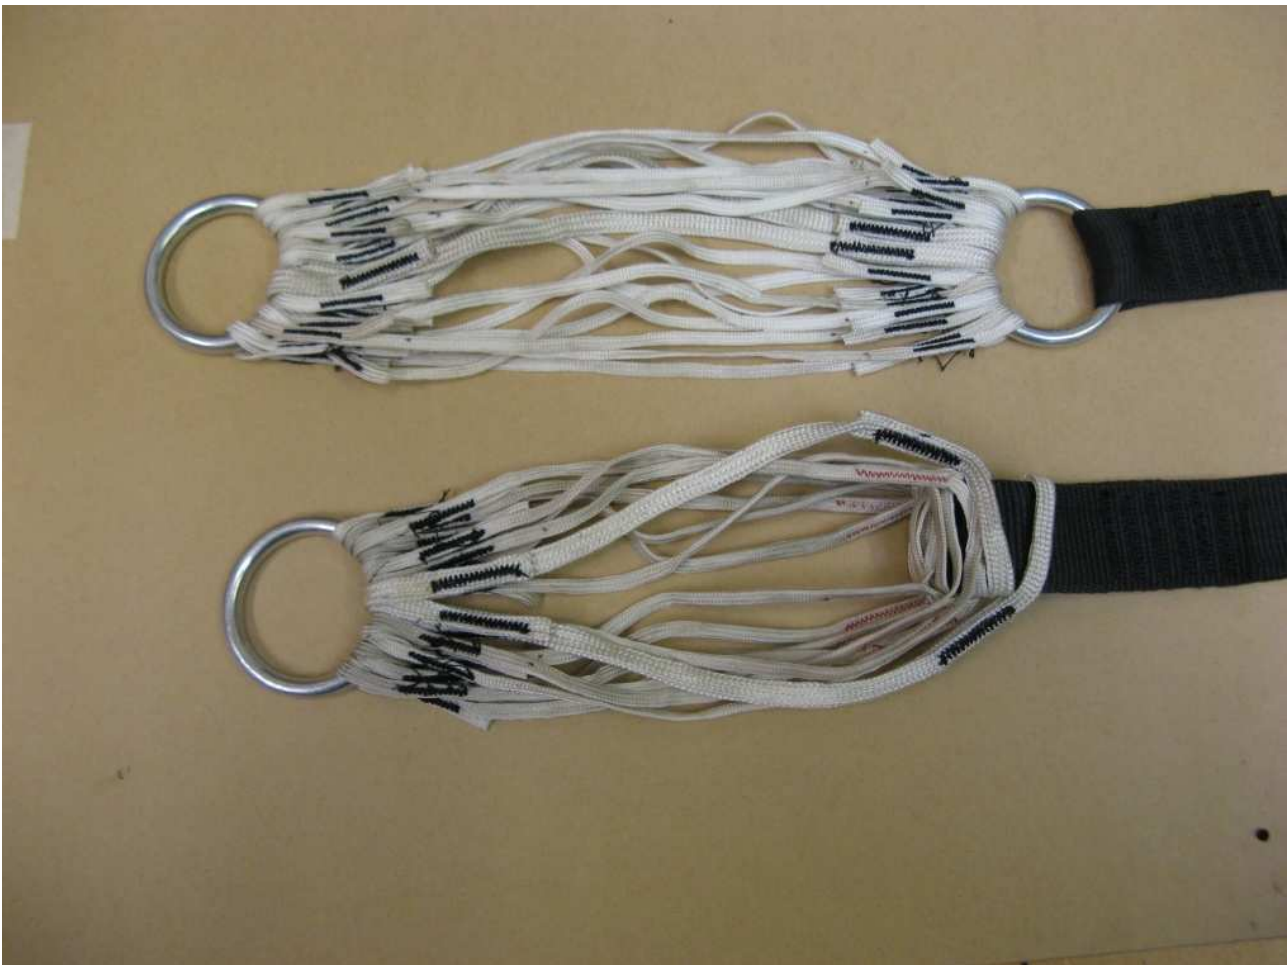
To test the difference in strength that a steel ring might have made to the webbing strap, I made up two test samples using short sections of the parachute strap. One sample used a steel ring to connect the parachute cords to the webbing, while the other had the cords sewn directly to the webbing in a similar manner to the original strap. These are shown in the photograph below.

In the test replicating the parachute strap configuration, the cords started to break at 13.4 kN, and the load diminished steadily as they continued to break. The webbing remained intact, so this test did not replicate the failure mode of the accident.

The sample with the rings held 15.1 kN before the first cord broke, and held a peak load of 16.1kN as the cords broke progressively.

As the failure mode was not replicated it is difficult to form any reliable conclusions, but of course there can be differences in failure modes depending on whether loads are applied via a slow-pull process such as this, or by sudden impact, as in the case in point. Commonly I find different failure modes in a series of tests in which the test samples have been created, as best we are able, to be identical, in that failure may occur sometimes in the webbing and sometimes in the stitching.
